BR700 SERIES PROPULSION SYSTEM SERVICE BULLETIN

ALERT SB-BR700-72-A900726

ENGINE - HIGH PRESSURE (HP) COMPRESSOR FRONT CASE - REPEAT BORESCOPE INSPECTION OF
THE HP COMPRESSOR STAGES 1 TO 4 FRONT CASE LINING - NON-MODIFICATION SERVICE
BULLETIN

BR700-725A1-12 Engines.

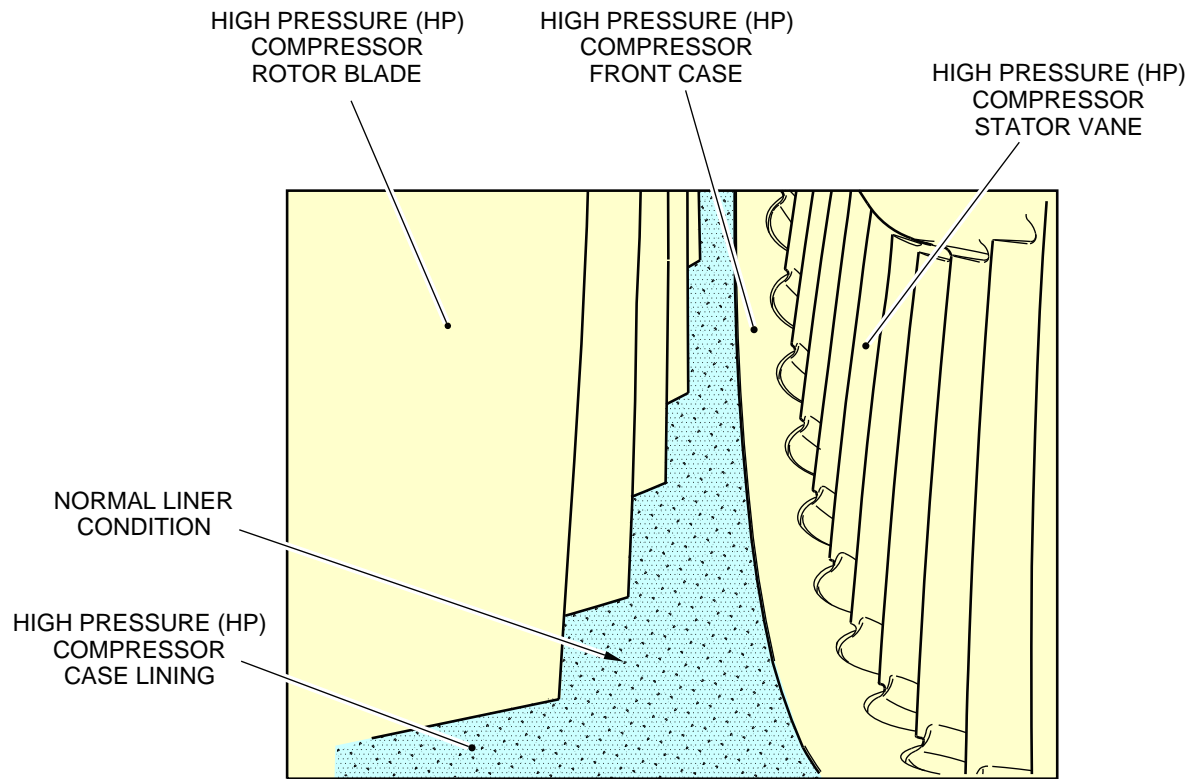
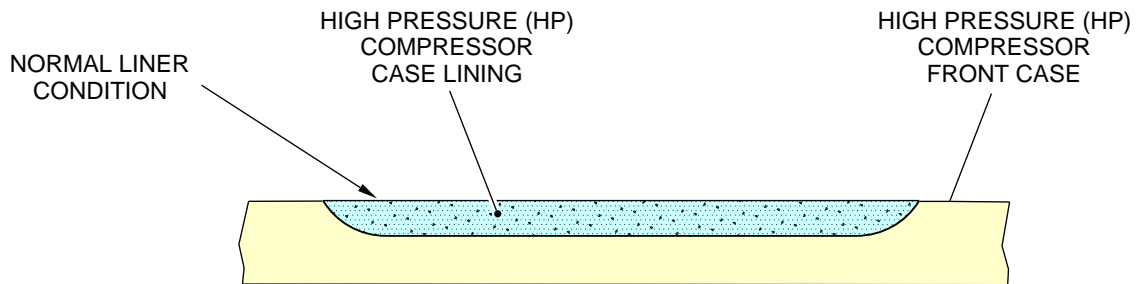
Borescope Inspection of HP Compressor Stages 1 to 4 Front Case Abrasive Lining
- NORMAL LINER CONDITION -
Figure 2 (Sheet 7 of 7)

(1) **NORMAL LINER CONDITION:** No damages to the liner surface, no breakouts and no liner loss (Refer to typical view on Figure 2, Sheet 7).

NORMAL LINER CONDITION: No damages to the liner surface, no breakouts and no liner loss.

TYPICAL HIGH PRESSURE (HP) COMPRESSOR CASE LINING WITHOUT DAMAGE

- (4) Complete the evaluation based on the inspection or re-inspection results (use the Tables 1 to 5 as required)
- (a) If normal condition (described in Figure 2, Sheet 7), rubbed condition (described in Figure 3, Sheet 1) and/or local surface chipping/pitting (described in Figure 3, Sheet 2) was found on stages 1 to 4, accept and do the borescope inspection in accordance with this Non-Modification Service Bulletin again, at intervals of not more than 25 flight cycles after the previous accomplishment.

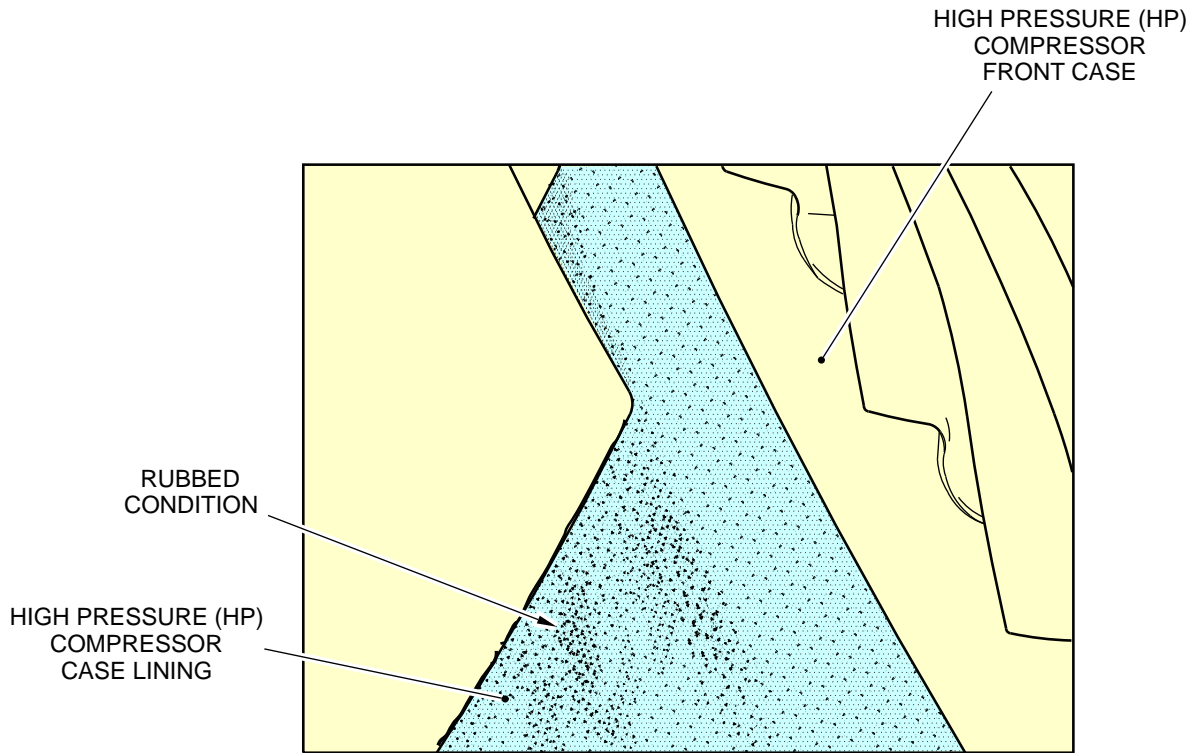
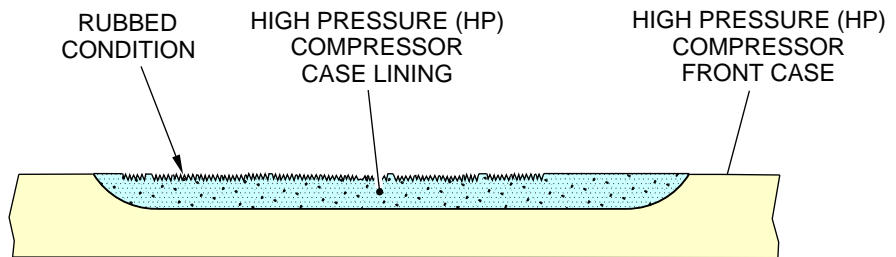
Borescope Inspection of HP Compressor Stages 1 to 4 Front Case Abrasive Lining
- RUBBED CONDITION -
Figure 3 (Sheet 1 of 6)

- (2) RUBBED CONDITION: Slight longitudinal grooves in circumferential direction at the liner surface only (Refer to typical view on Figure 3, Sheet 1).

RUBBED CONDITION: Slight longitudinal grooves in circumferential direction at the liner surface only.

TYPICAL HIGH PRESSURE (HP) COMPRESSOR CASE LINING WITH RUB MARKS

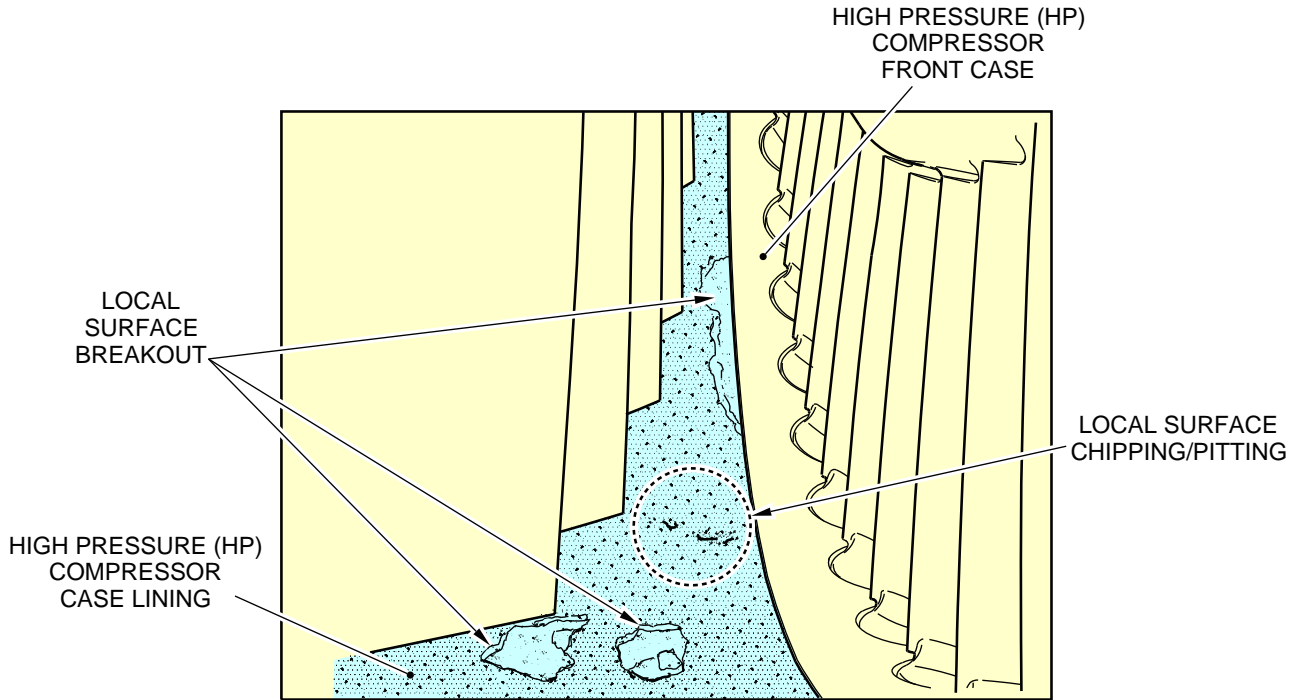
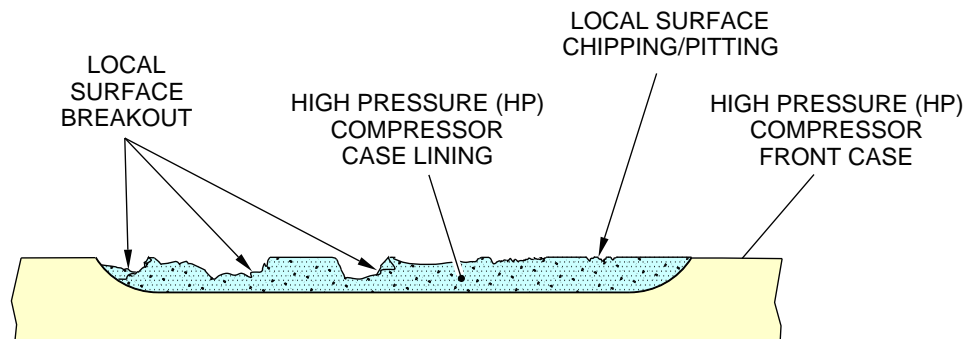
- (3) LOCAL SURFACE CHIPPING/PITTING: Local notches, cavities or other impacts at the liner surface only (Refer to typical view on Figure 3, Sheet 2).
- (4) LOCAL SURFACE BREAKOUT: Local liner material loss deeper below the liner surface, but not down to the case material at the bottom of the liner pocket (Refer to typical view on Figure 3, Sheet 2).

LOCAL SURFACE CHIPPING/PITTING: Local notches, cavities or other impacts at the liner surface only.

LOCAL SURFACE BREAKOUT: Local liner material loss deeper below the liner surface, but not down to the case material at the bottom of the liner pocket.

TYPICAL HIGH PRESSURE (HP) COMPRESSOR CASE LINING WITH LOCAL SURFACE CHIPPING/PITTING AND LOCAL SURFACE BREAKOUT

- (b) If local surface breakout (described in Figure 3, Sheet 2) was found on stages 1 to 4:
- [1] If up to 9,7 percent (three affected blade sectors) of local surface breakout was found on stages 1, accept and do the borescope inspection in accordance with this Non-Modification Service Bulletin again, at intervals of not more than 25 flight cycles after the previous accomplishment.

- [2] If up to 8,1 percent (three affected blade sectors) of local surface breakout was found on stages 2, accept and do the borescope inspection in accordance with this Non-Modification Service Bulletin again, at intervals of not more than 25 flight cycles after the previous accomplishment.

- [3] If up to 5,1 percent (three affected blade sectors) of local surface breakout was found on stages 3, accept and do the borescope inspection in accordance with this Non-Modification Service Bulletin again, at intervals of not more than 25 flight cycles after the previous accomplishment.

- [4] If up to 5,1 percent (four affected blade sectors) of local surface breakout was found on stages 4, accept and do the borescope inspection in accordance with this Non-Modification Service Bulletin again, at intervals of not more than 25 flight cycles after the previous accomplishment.

- (c) If more local surface breakout (described in Figure 3, Sheet 2) than accepted above was found on stages 1 to 4, reject the engine
- [1] Provide also the completed Tables 1 to 5 together with a video-copy of the borescope inspection to Rolls-Royce Deutschland, Service Engineering.

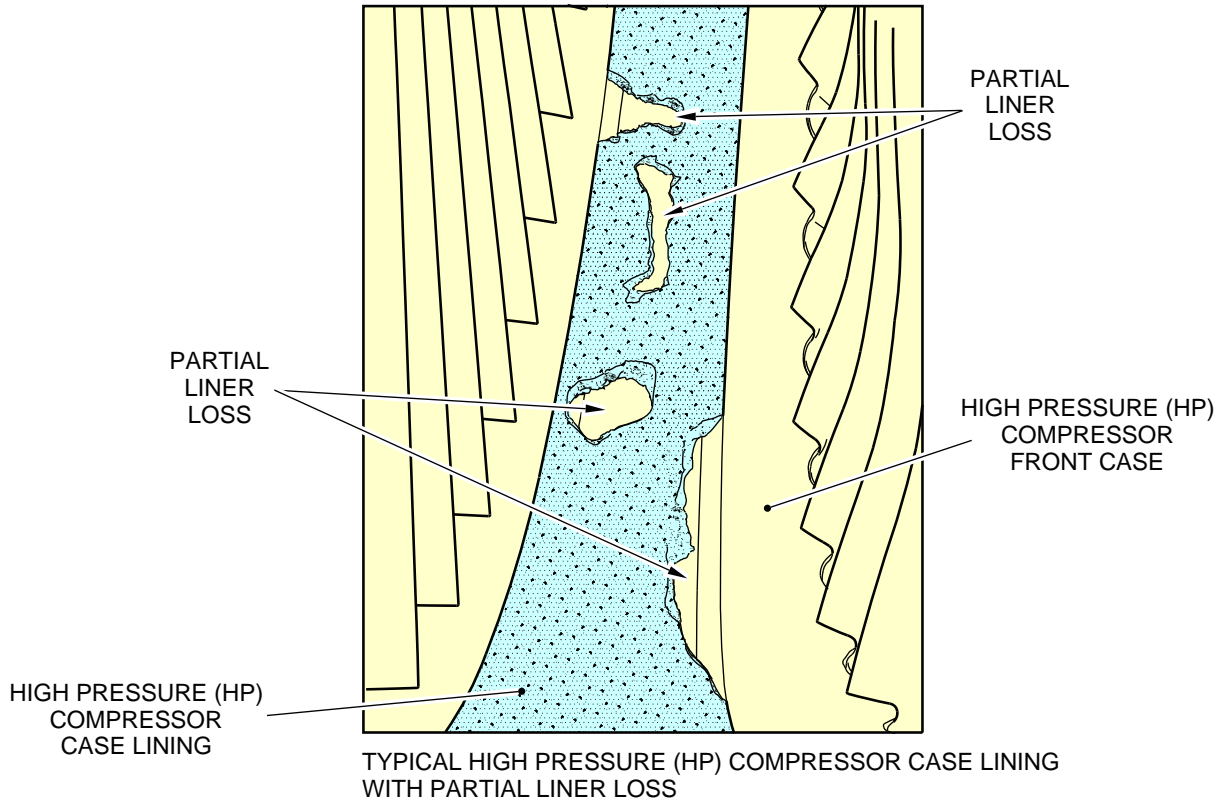
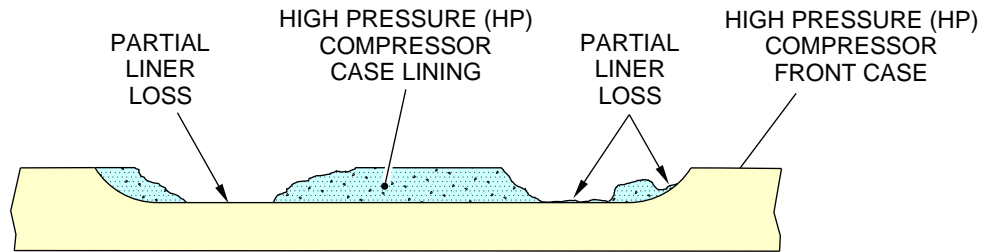
- (5) PARTIAL LINER LOSS: Liner material loss down to the case material at the bottom of the liner pocket, but not over the complete liner pocket width from front to rear (Refer to typical view on Figure 3, Sheet 3).

PARTIAL LINER LOSS: Liner material loss down to the case material at the bottom of the liner pocket, but not over the complete liner pocket width from front to rear.

TYPICAL HIGH PRESSURE (HP) COMPRESSOR CASE LINING WITH PARTIAL LINER LOSS

- (d) If partial liner loss (described in Figure 3, Sheet 3) and/or complete liner loss (described in Figure 3, Sheet 4) was found on any stage of stages 1 to 4, reject the engine

- E. In case partial liner loss (described in Figure 3, Sheet 3) on any of the HP compressor stages 1 to 4 front case liners has been found, examine the HP compressor stages 1 to 4 rotor blades in accordance with the Aircraft Maintenance Manual, Chapter 72-00-00, PB601.

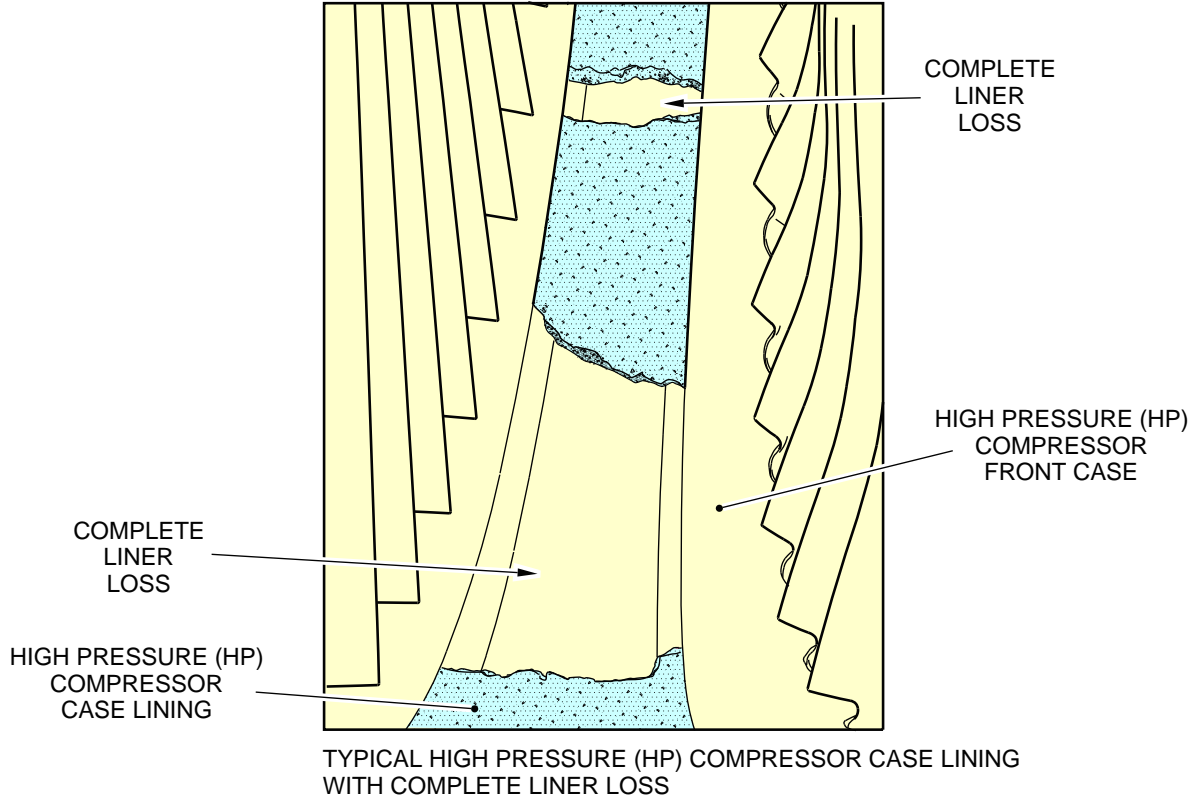
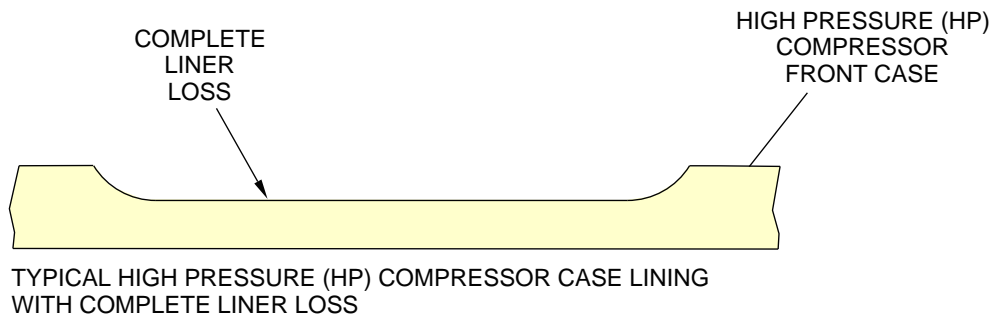
- (6) COMPLETE LINER LOSS: Liner material loss down to the case material at the bottom of the liner pocket, over the complete liner pocket width from front to rear (Refer to typical view on Figure 3, Sheet 4).

COMPLETE LINER LOSS: Liner material loss down to the case material at the bottom of the liner pocket, over the complete liner pocket width from front to rear.

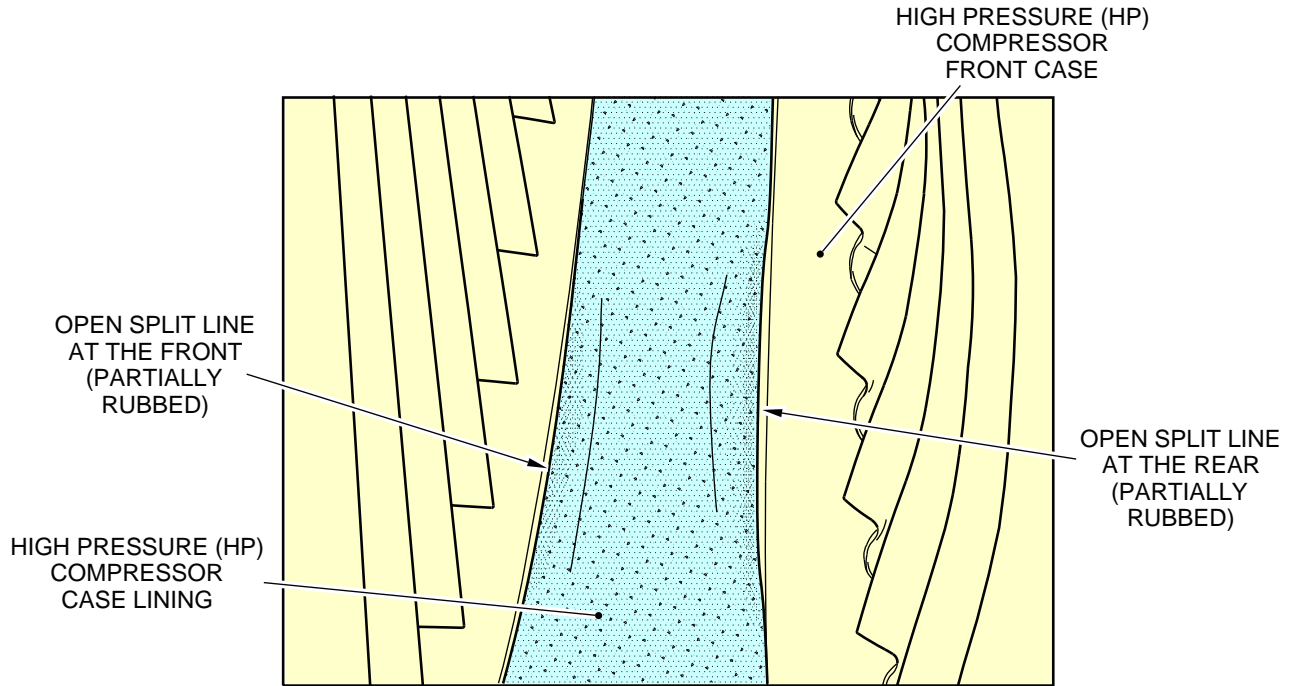
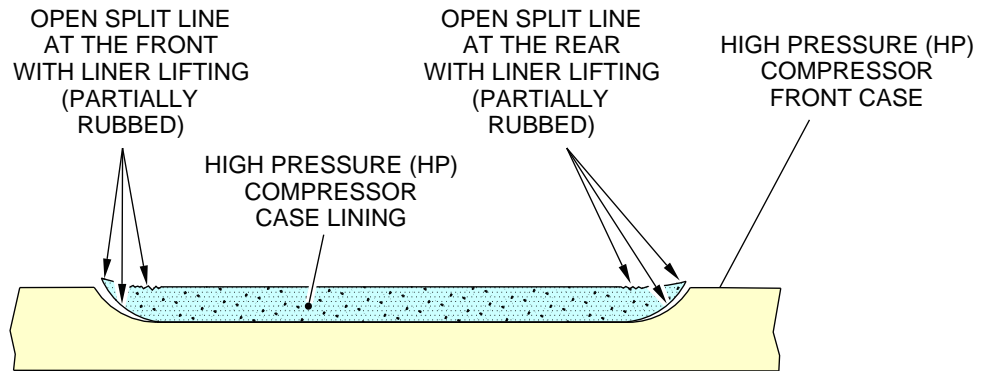
Borescope Inspection of HP Compressor Stages 1 to 4 Front Case Abrasive Lining - OPEN SPLIT LINE CONDITION -
Figure 3 (Sheet 5 of 6)

- (7) OPEN SPLIT LINE CONDITION: Liner material detachment between the liner and the case in circumferential direction, also with liner lifting and with partially rubbing at the lifted liner (Refer to typical view on Figure 3, Sheet 5).

OPEN SPLIT LINE CONDITION: Liner material detachment between the liner and the case in circumferential direction, also with liner lifting and with partially rubbing at the lifted liner.

TYPICAL HIGH PRESSURE (HP) COMPRESSOR CASE LINING WITH OPEN SPLIT LINE CONDITION

- (e) If open circumferential split line condition without Liner Lifting (with or without cracking and with or without partially rubbing) (described in Figure 3, Sheets 5 and 6) per stage (stages 1 to 4) was found, accept and do the borescope inspection in accordance with this Non-Modification Service Bulletin again, at intervals of not more than 25 flight cycles after the previous accomplishment.
- (f) If open circumferential split line condition with Liner Lifting (with or without cracking and with or without partially rubbing) (described in Figure 3, Sheets 5 and 6) was found on any stage of stages 1 to 4, reject the engine

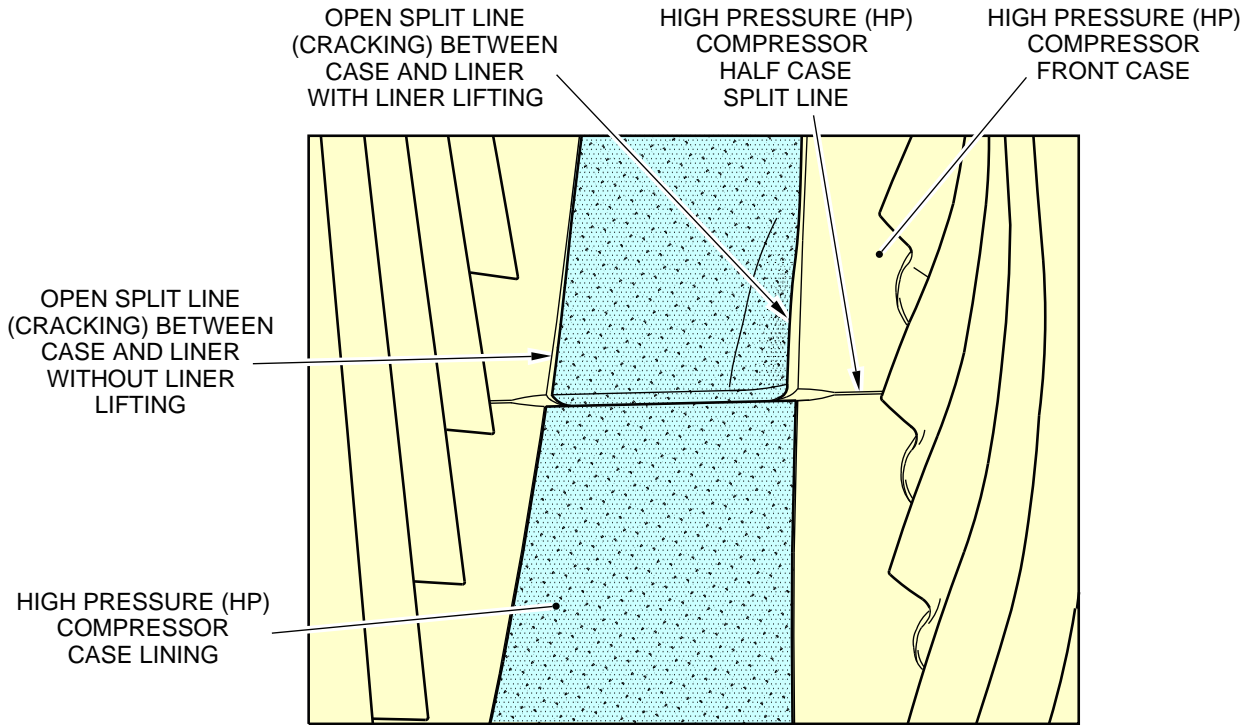
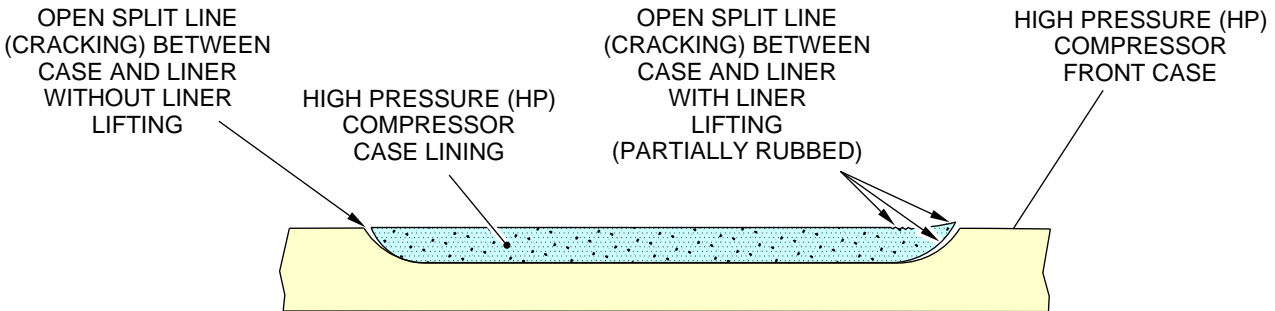
Borecope Inspection of HP Compressor Stages 1 to 4 Front Case Abrasive Lining - OPEN SPLIT LINE (CRACKING) AT HALF CASE SPLIT LINE - Figure 3 (Sheet 6 of 6)

- (8) OPEN SPLIT LINE (CRACKING) AT HALF CASE SPLIT LINE: Liner material detachment between the liner and the case at the half case split line, also with liner lifting and with partially rubbing at the lifted liner (Refer to typical view on Figure 3, Sheet 6).

Liner material detachment between the liner and the case at the half case split line, also with liner lifting and with partially rubbing at the lifted liner.

TYPICAL HIGH PRESSURE (HP) COMPRESSOR CASE LINING WITH OPEN SPLIT LINE (CRACKING) BETWEEN CASE AND LINING AT THE HALF CASE SPLIT LINE
